RE: Preliminary Assessment for **Sitkinak Loran A Station**
AK5141190087

Encl: Preliminary Assessment for Sitkinak Loran A Station

PRELIMINARY ASSESSMENT SITKINAK LORAN A STATION

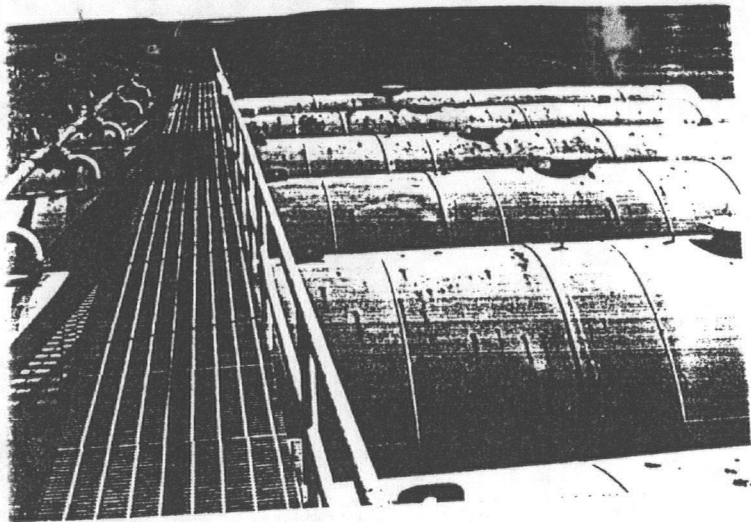
View of the above ground fuel oil storage tanks ~~passing~~ East towards the situated of lagoon. These tanks are approximately 25 ft. from the 600' ft. over-run near the north end of the runway.

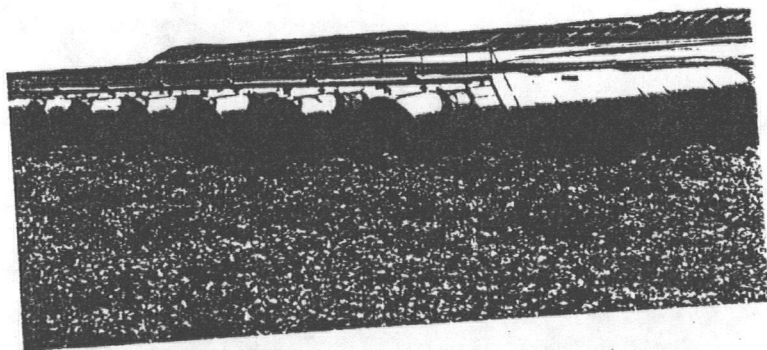
Northeast view from on top of the catwalk extending across the fuel oil tanks. Over-all condition of the top section on the tanks are in fairly good shape, considering how long they've been out of service.

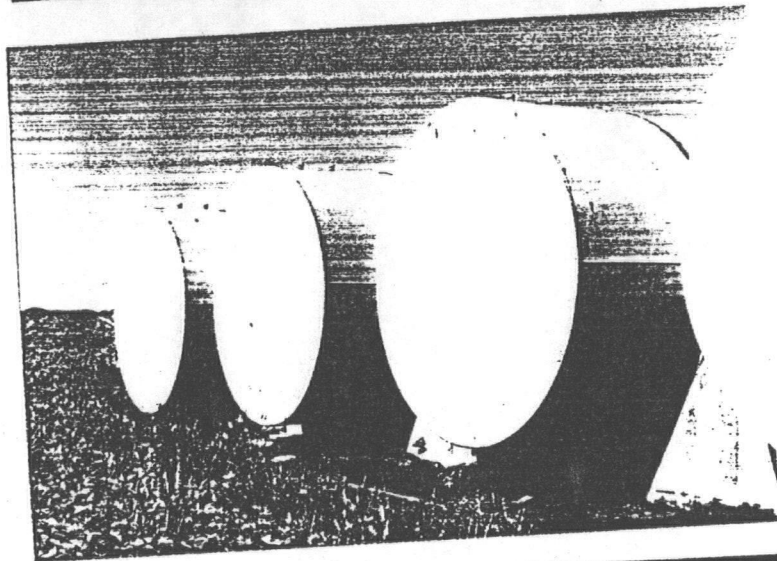
There was no evidence of any spillage between the west wall and the east wall. The spillage area is on the backside of the east wall facing the saltwater lagoon. Much of the fuel has spread out over an area of 25 feet from the end of the tanks and has migrated to about 90 feet downgrade along the east wall of the foundations. Enclosure 1, page 3B.

View of the South-east side of the Storage tanks were a large area of fuel oil has spilled into the ground. These tanks are numbered as 1, 2, & 3.

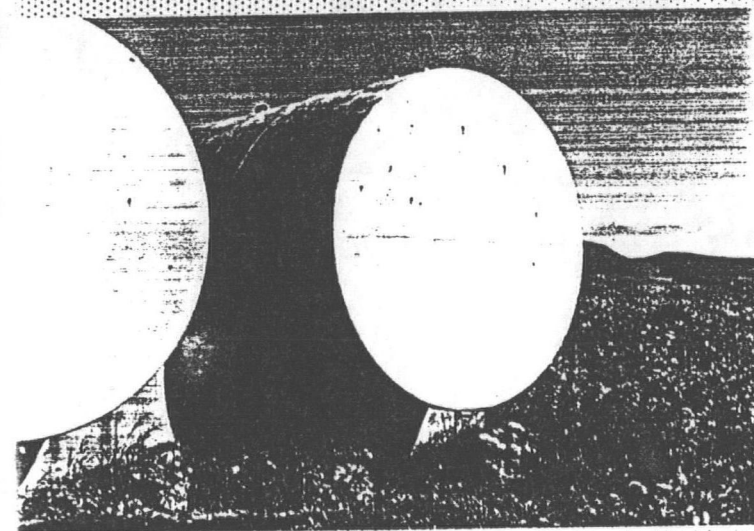
Tanks #6 & #7. Same conditions also exist here as in the other areas of the tank farm.

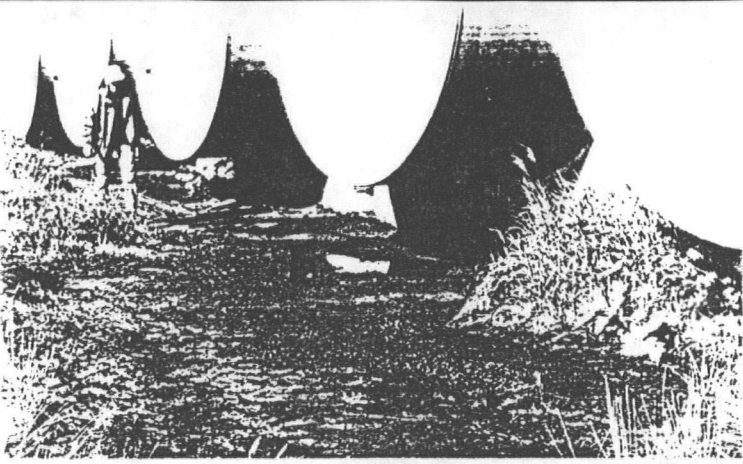
View looking up slope from Tank #7 to Tank #1 of contaminated area. The fuel oil contamination can be seen to extend 25 ft. beyond the tanks and spreads out as it flows down grade.

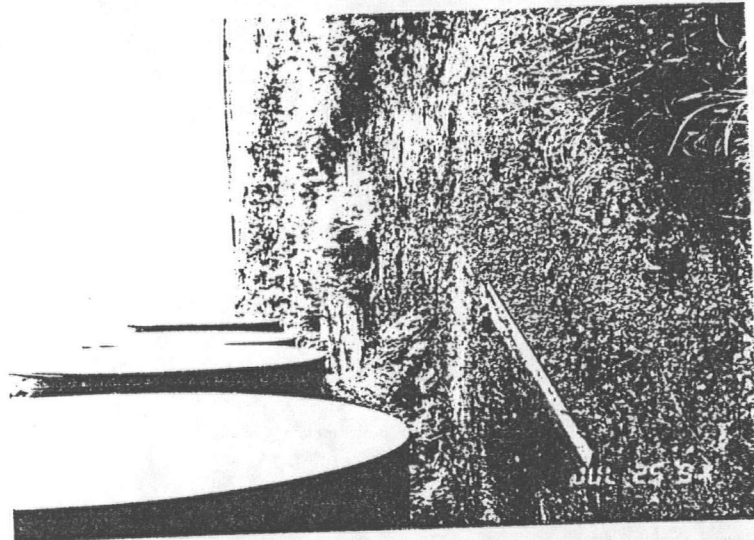
View of the contaminated area looking down slope from Tank #3 to #7. The extent of the contamination can be seen quite well here. The fuel oil is slowly migrating into a nearby stream that connects to the saltwater lagoon to the east.

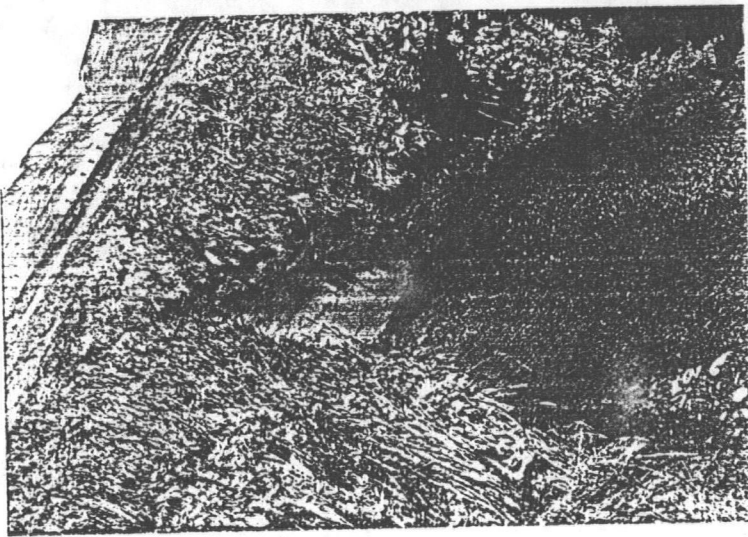
View looking west of the fuel oil storage tanks. The discharge of contaminants from both the storage tanks & the sewage treatment plant has adversely effected the stream. Several oily deposits can be seen throughout the portion of the stream.

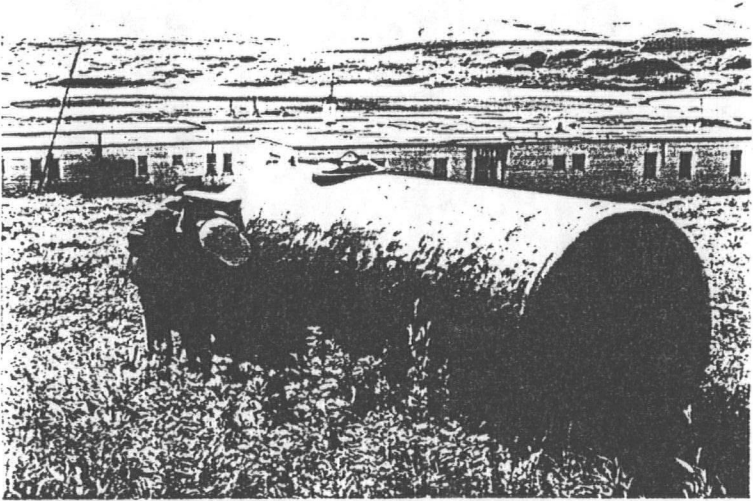
Green Storage Tank: There is no evidence of leakage or spills from this tank. The use and contents of the tank is unknown at this time. The capacity of the tank is approximately 800 gallons. We were unable to sound the tank due to the rust buildup on the tank caps. Enclosure 1, page 3A.

*Green storage tank just behind
and below the tanks, no
evidence of any leakage or
spills. Content and use are
unknown at this time.*

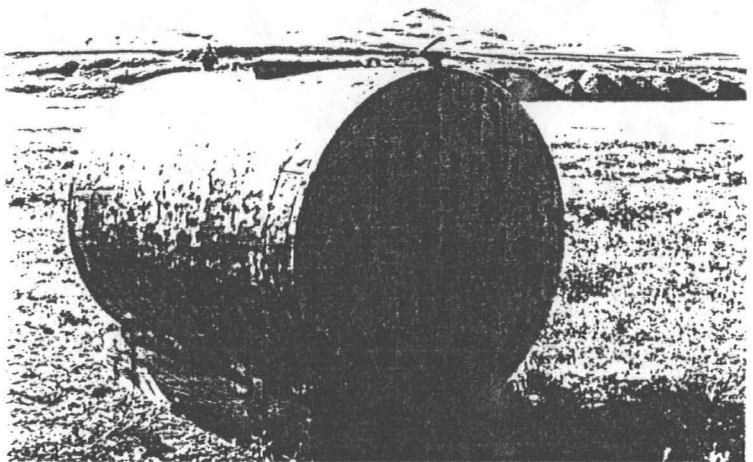
Yellow Storage Tank: There is no evidence of leakage or spills from this tank. The use and contents of this tank is unknown at this time. The capacity of the tank is approximately 600 gallons. We were unable to sound the tank due to the rust buildup on the tank caps. Enclosure 1, page 3A.

*Another storage tank located
just behind the SP-5 refueling
area. No evidence of leakage
from this tank. Contents &
use are unknown at this time.*

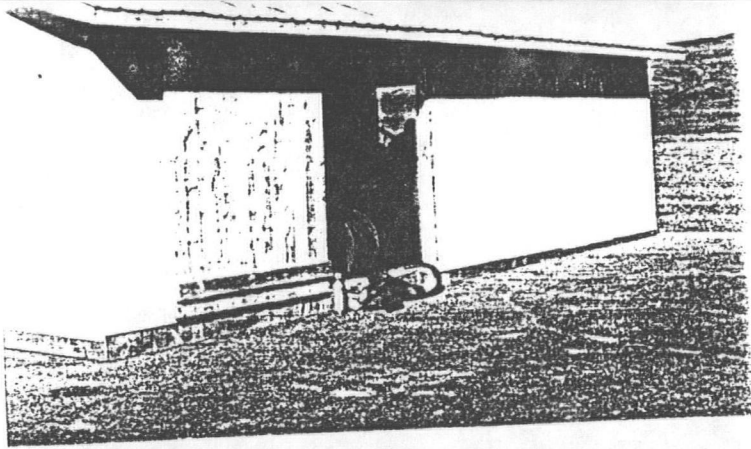
JP-5 storage shed used to house the emergency JP-5 fuel tank used by CG KDKAS.

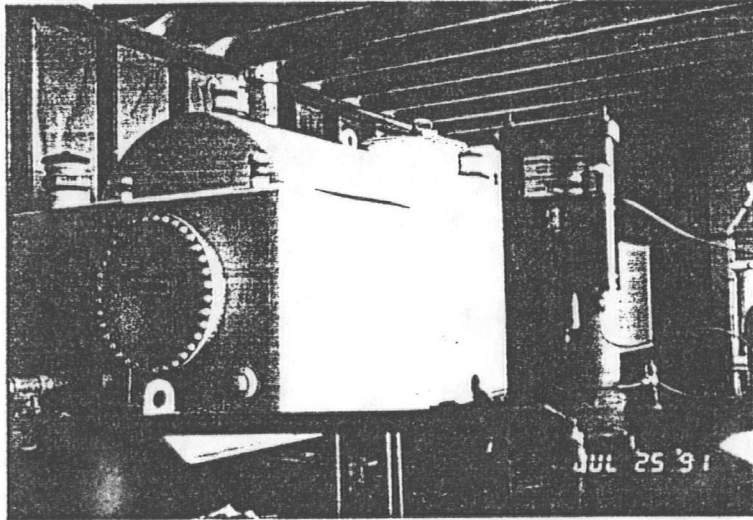
Picture of the JP-5 emergency refueling system used to refuel the CG HH-3's. Periodical testing is done to survey the fuel & the water content percentages.

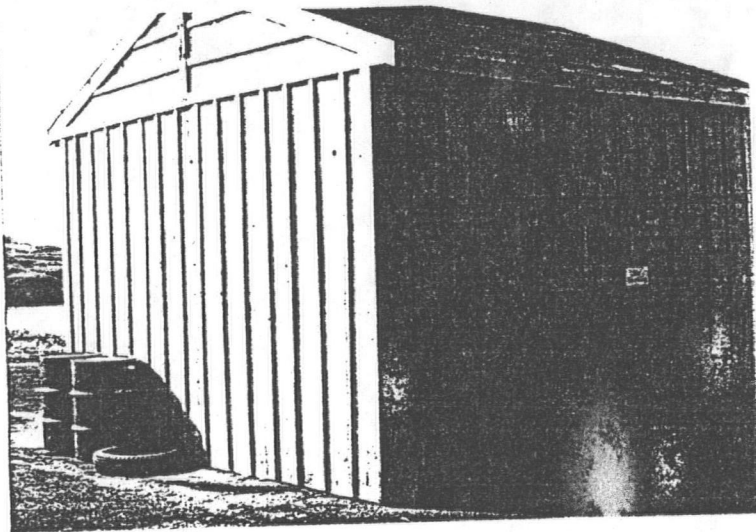
Storage shed used by the CG KDKAS for various miscellaneous items. A storage cabinet is used to house several pint size solvent containers. The two red drums are used to store waste JP-5 & water accumulated during their bi-monthly testing of the JP-5 fuel tanks.

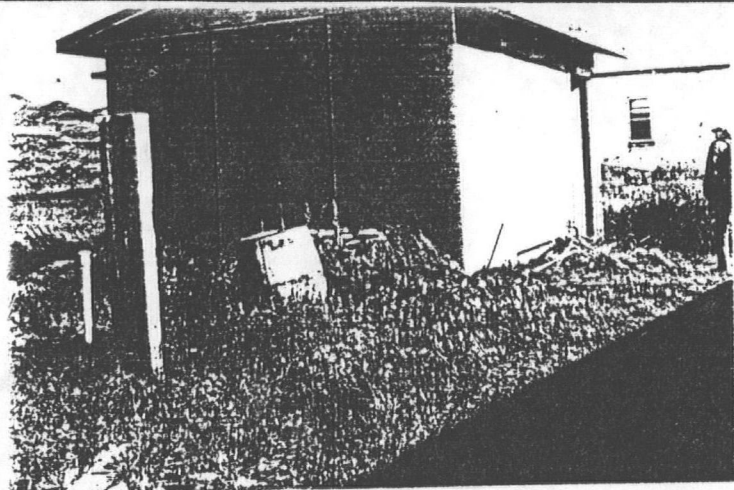
Picture of the back of the incinerator building used to burn the rubbish generated by the facility at one time. An old drum has been abandoned, contents unknown. There is also an 1,000 gallon diesel fuel tank used to power the incinerator. The building is now being used as a steam room by the ranchers.

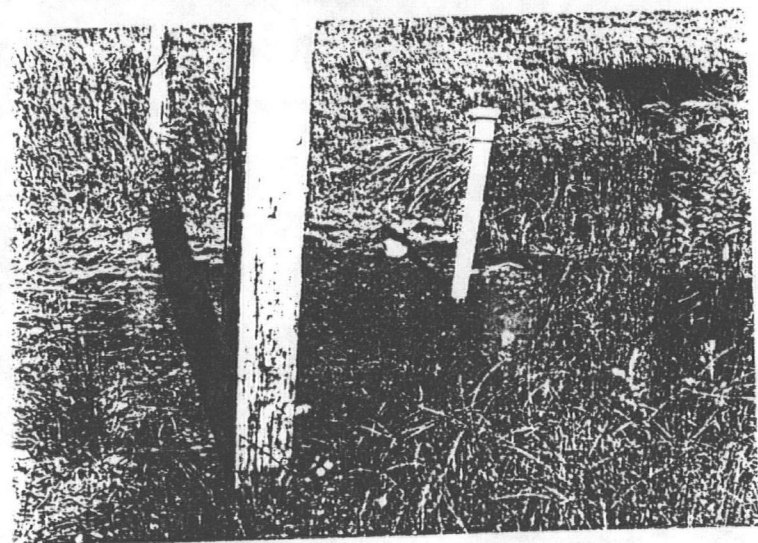
There is a large fuel contaminated area surrounding the fill pipe of this tank, measuring some 10 square feet. The fill pipe cap was found opened at the time of inspection. The tank could have filled up with water at some point, thereby pushing the remaining material to the top of the tank and out the fill tube. The spill area is approximately 7 feet in diameter. Enclosure 1, page 3.

Fill pipe on the 1,000 diesel tank just behind the incinerator building. There is a large amount of fuel oil that has spilled over onto the surrounding area saturating the soil.

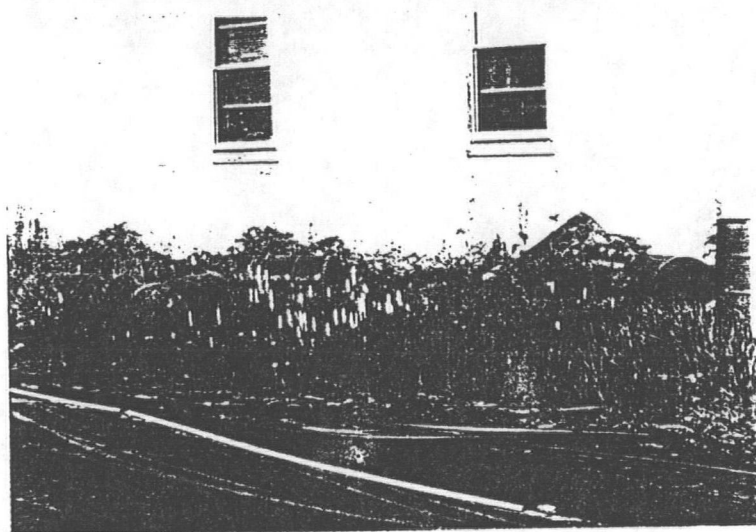
Picture of the old storage drums used at the facility lying around the inside compound area. The drums are weathered and are empty.

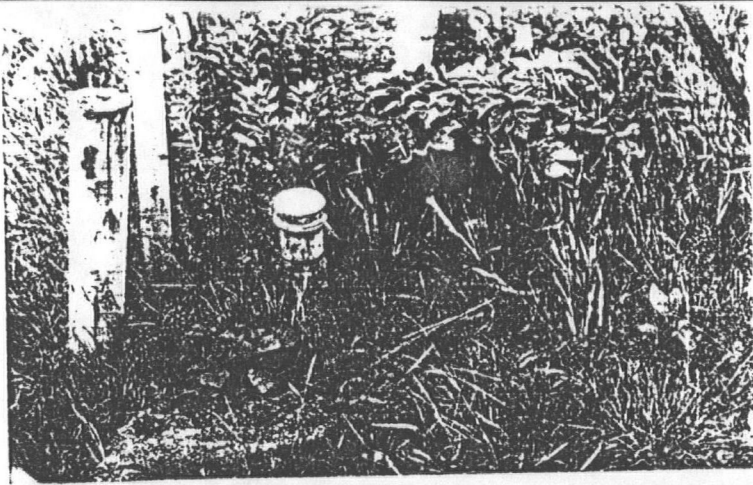
Fill pipe on the 2,000 gallon
UST used to house gasoline.
one is located near the south-
west wall of the Signal &
Power building. No evidence
of any spills or leakage.

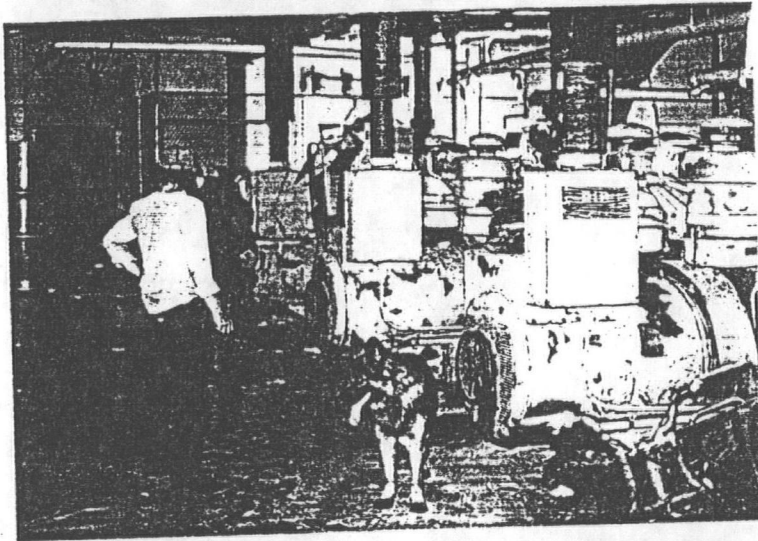
Close-up view of the Signal & Pow-
er building. Picture shows several
generators used to power the
facility. Abandoned empty
storage drums stored in this
area. Drums appear fairly
new - may belong to the
ranch hands.

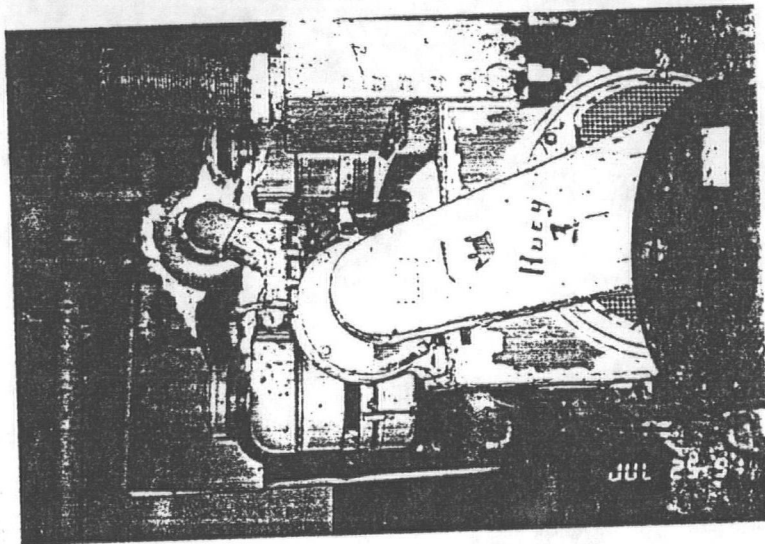
Crumbling Asbestos is laying
on and around the generators
much of the material has
started to deteriorated and
may cause a breathing hazard

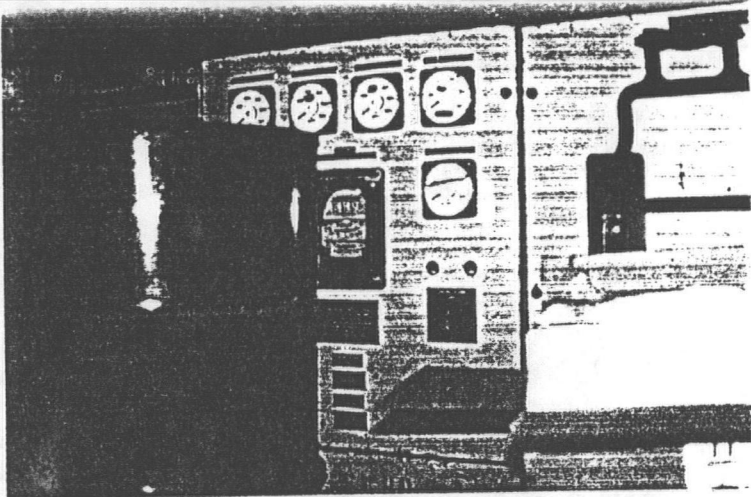
View of the electrical control panels & equipment used at the facility.

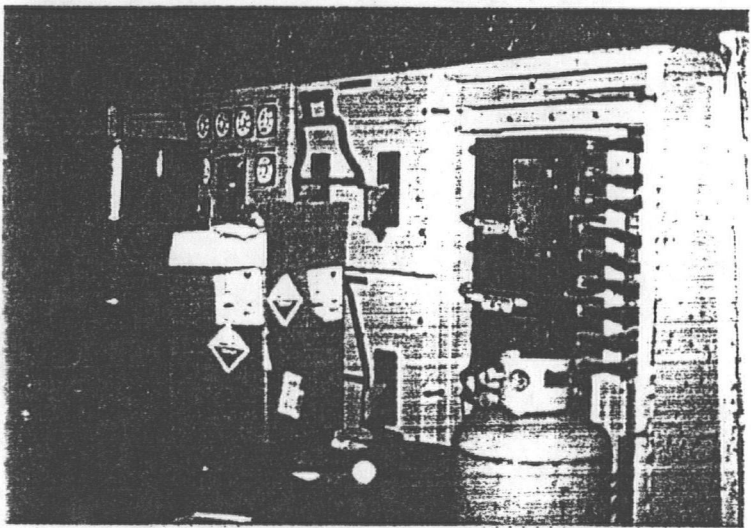
Another view of the electrical panels & equipment used by the facility at one time.
Possible that some of the electrical equipment is PCB filled. Will need to dismantle the unit to confirm.

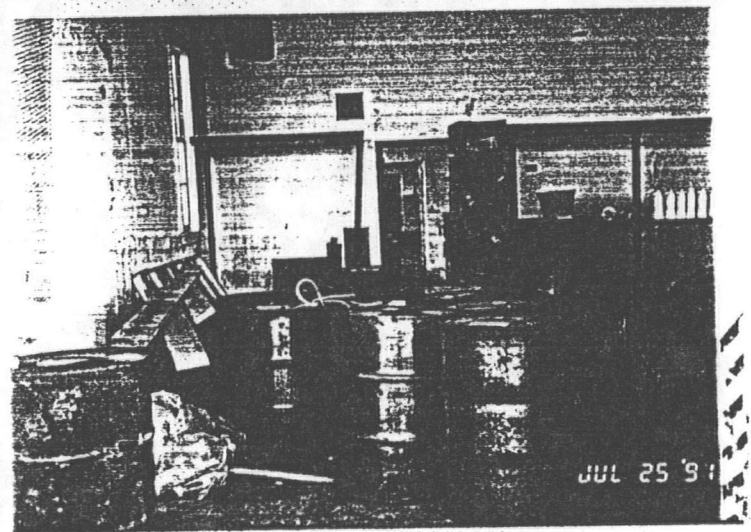
Some more empty storage drums stored inside the signal & power building.

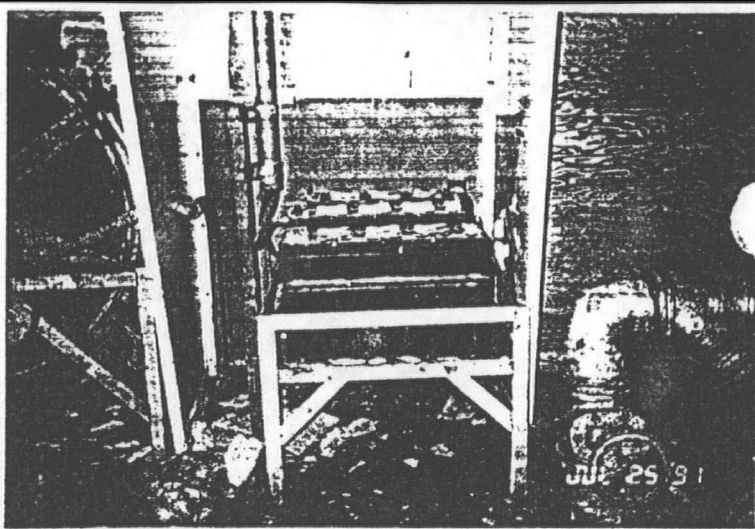
Abandoned batteries could be seen at several locations throughout the power building.

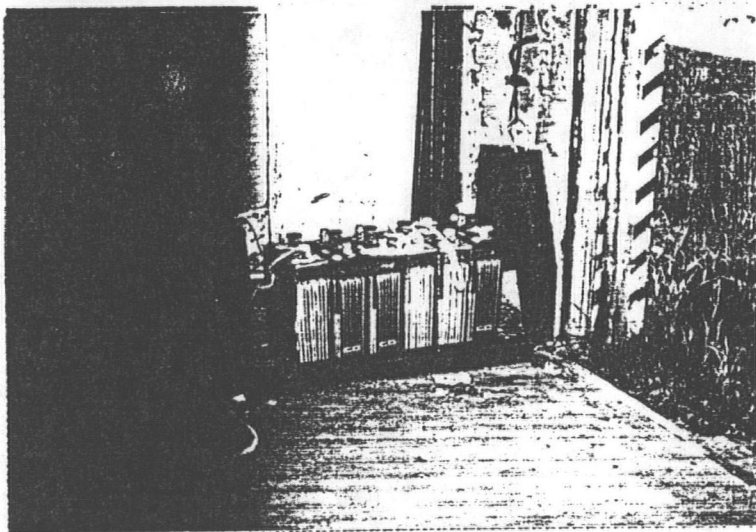
Again, some more abandoned batteries used to provide power to some units as a backup.

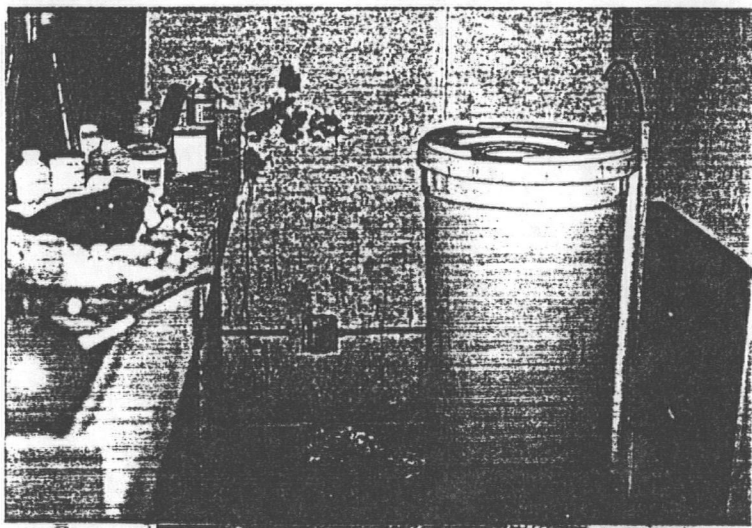
Upon entering this building, there was a noticeably strong chloride smell, which originated from the front portion of the building. There are a number of different lab chemicals lying about and a full 55-gallon plastic drum holding approximately 10 gallons of an unknown liquid which was standing in the corner. Within this room, there was a spot next to the plastic 55-gallon drum which appears to have deteriorated (corrosive?) in on itself at one time. The overall condition of this building was real poor, due to the large number of chemicals left open which spilled into the work area. Enclosure 1, pages 3, 3C.

A very strong chloride smell was coming from this building. The conditions of the area were very poor - a lot of live chemicals were laying about.

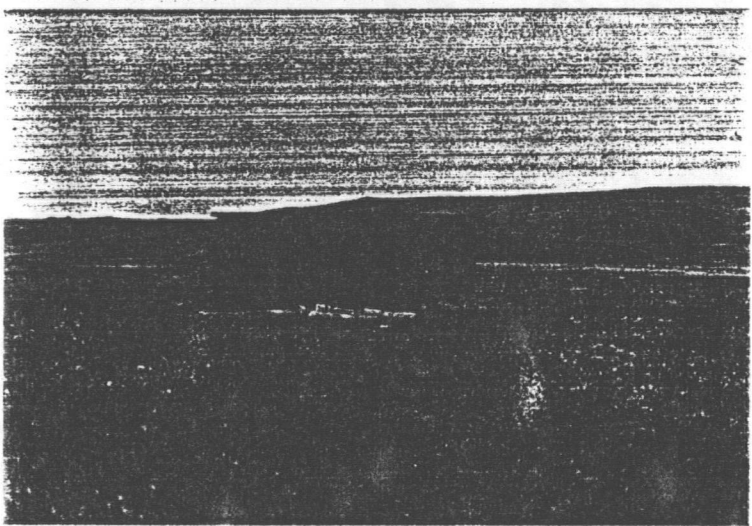
View looking East at the transmitter Building. Parts of the roof were laying about the surrounding area.

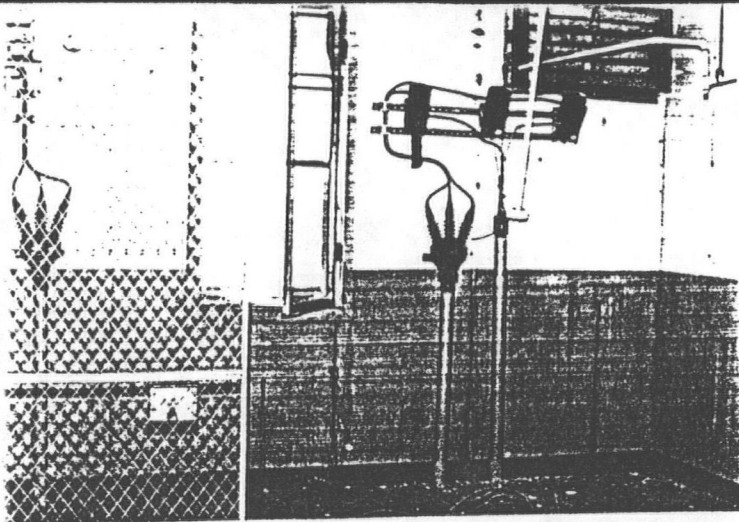
Inside transmitter building
showing 2 potheads mounted
on the south wall.

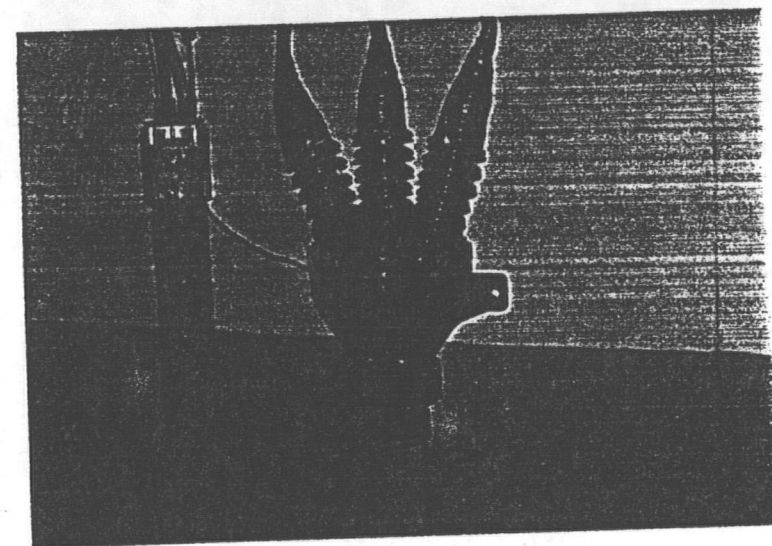
Pothead #2, with a little
effort these units could
be removed & packaged
for disposal.

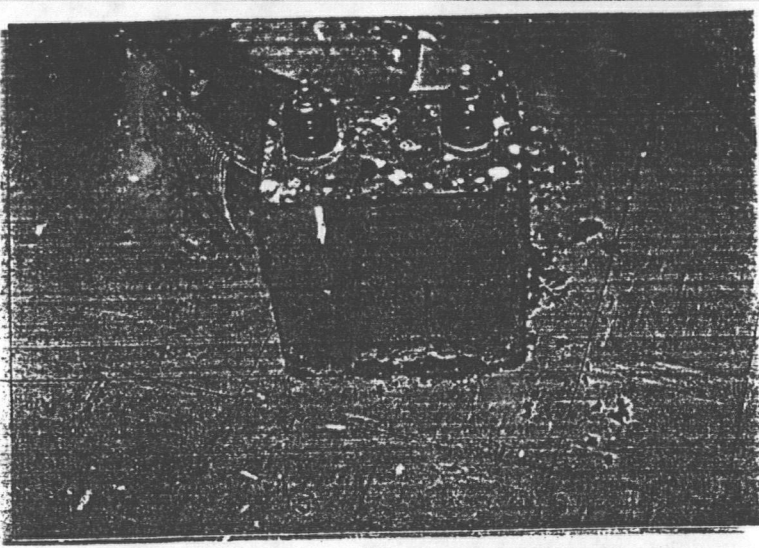
A 100 lb. capacitor that was used as a door stop.

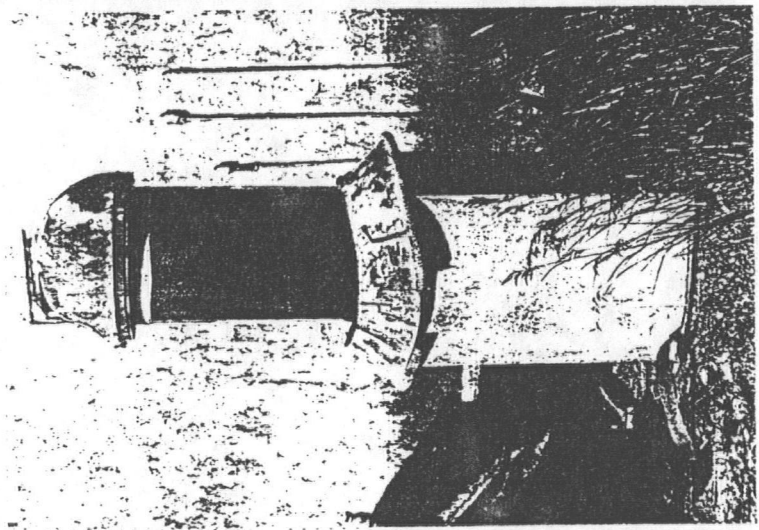
Located on the back side (west) of the building can be found a large insulator where the old transmitter tower used to sit some time ago. After speaking with the Support Center electrical engineer, it was determined that this unit is a dry-type electrical item containing no PCB fluid. Enclosure 1, pages 2, 3C.

This unit was located outside on the East wall. On electrical unit were the base of the antenna had once sat.

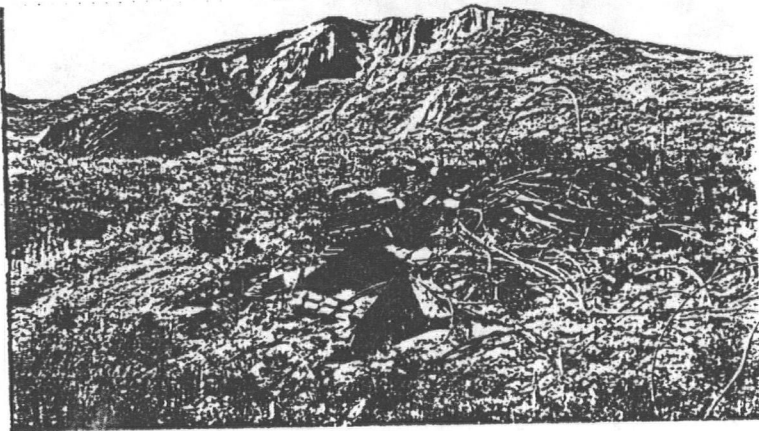
Battery dump site found on the way to landfill area #1, located South west of the facility.

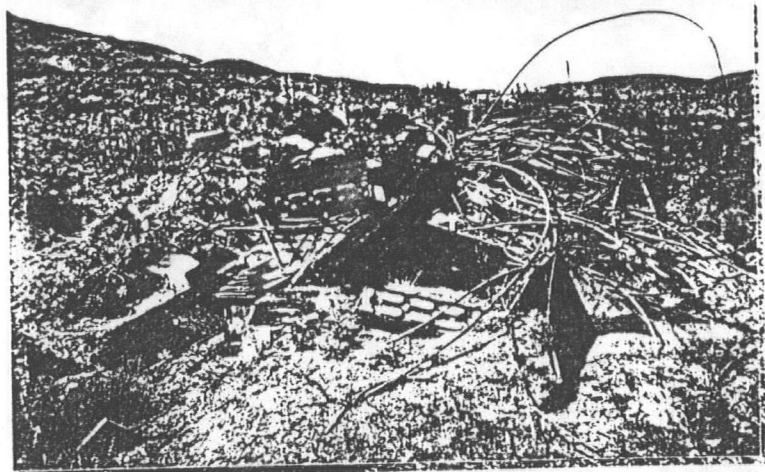
*A closer look at the
same dump site.*

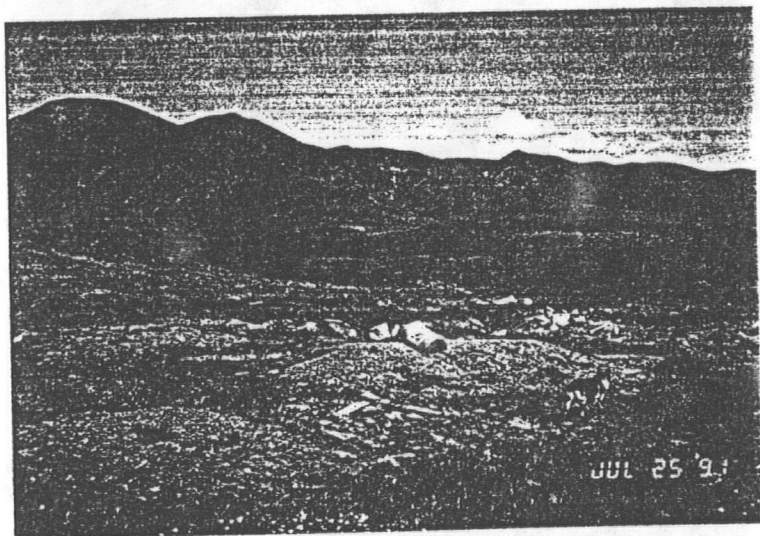
*View of the landfill facing
North with various items found
partially buried.*

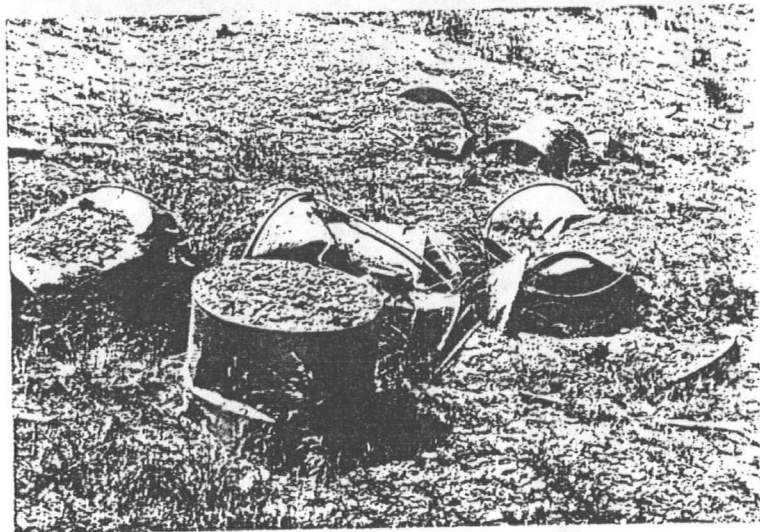
*An undetermined number
of drums were found partially
buried at several locations
throughout the landfill. Com-
bination of wind, rain runoff to
the south slope has exposed
most of the items. Drums
were empty at time of inspection.*

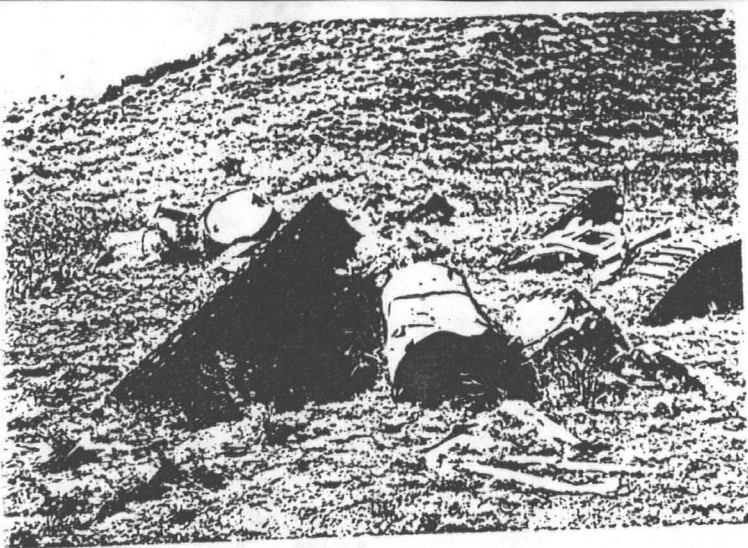
Several drums and tanks
parts were found partially
exposed due to runoff
from north slope area.

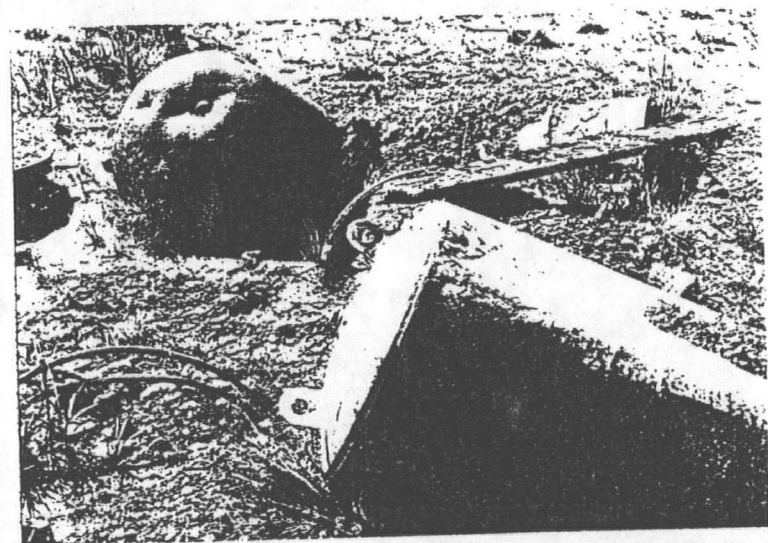
Partially exposed compressor
or storage tanks found in
the landfill.

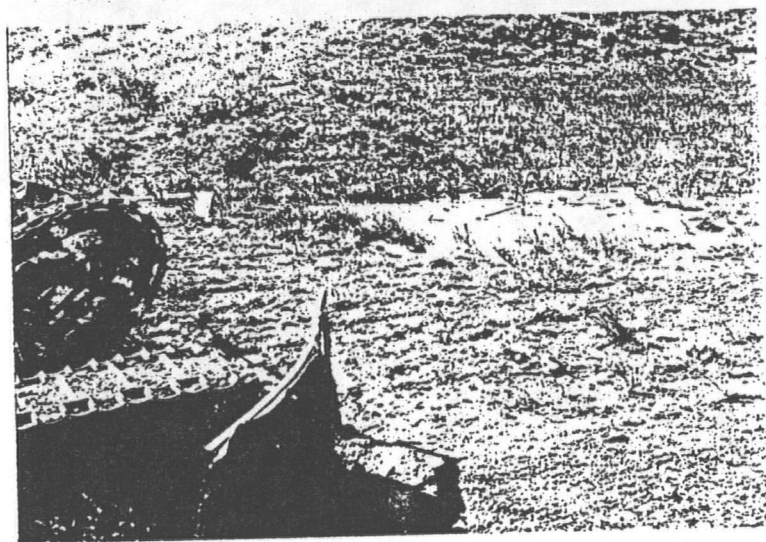
Small pools of water, or
a substance had accumulated
on the surface of the landfill.
This was to only unrecognizable
deposit in the area.

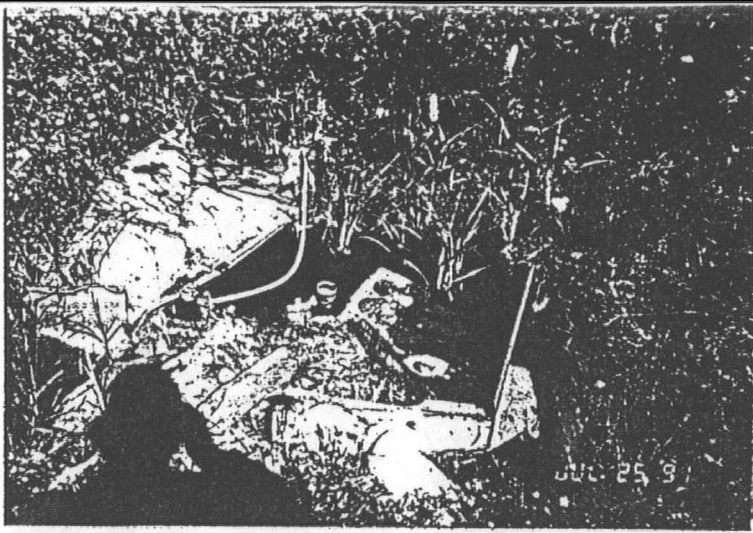
Water that has accumulated in 4 around a partially exposed engine block..
Please note that the color of both parts of water are different.

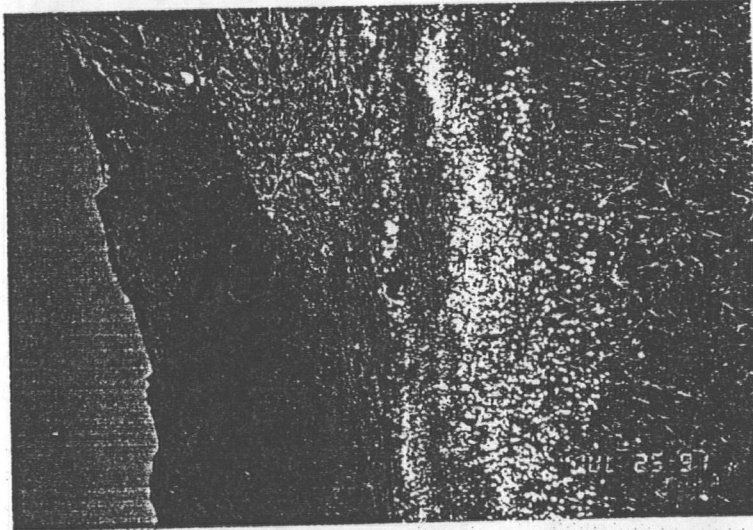
View looking due south across the landfill up the slope. run-off from the slope is depositing in the landfill and is then pushed out of the landfill again by heavy rains.

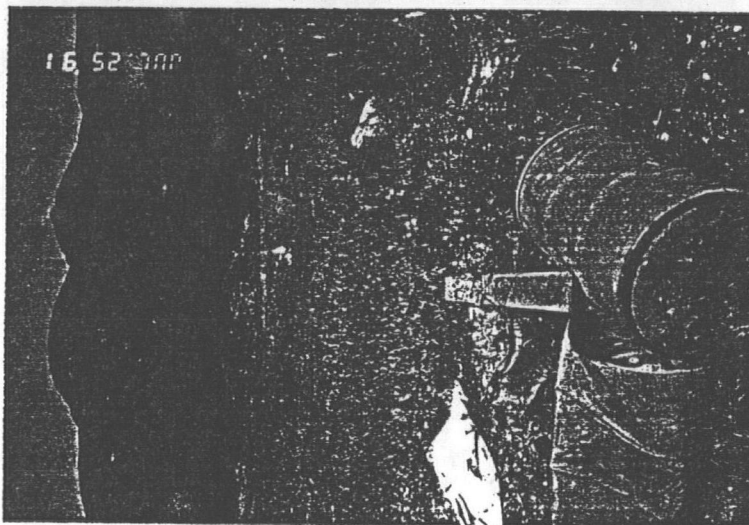
View looking north from the slope out across the landfill. Much of the runoff from the south slope is washing into the landfill.

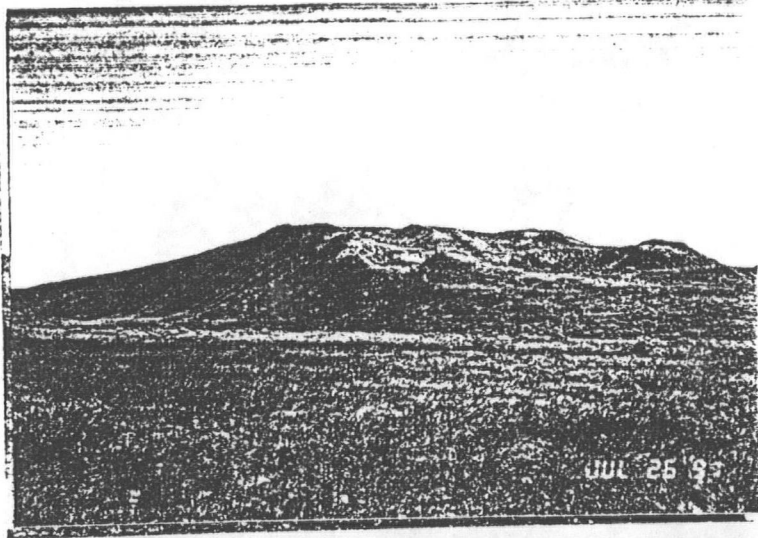
View of the 2nd landfill
from the road, located
north of the facility.
The landfill is located just
off the access road leading
to the beach.

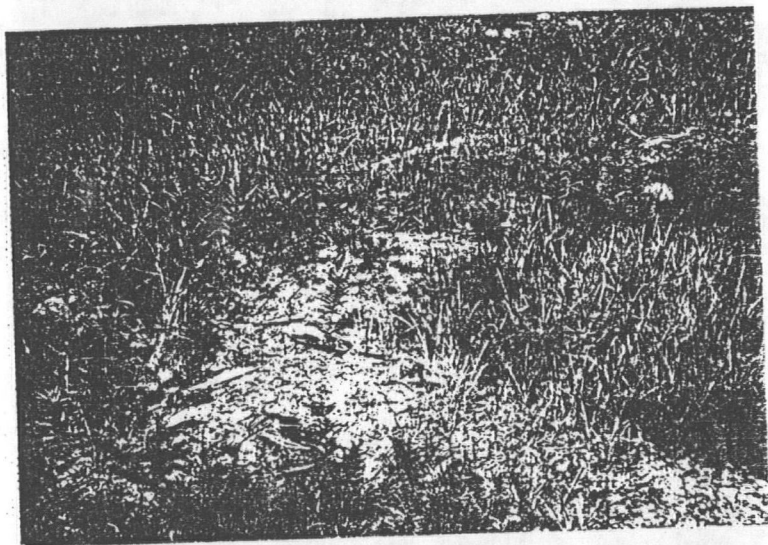
Very old battery dump site
found along the trail lead-
ing up to the landfill. This
site appears to contain the
innards of broken batteries
which have deteriorated
over time.

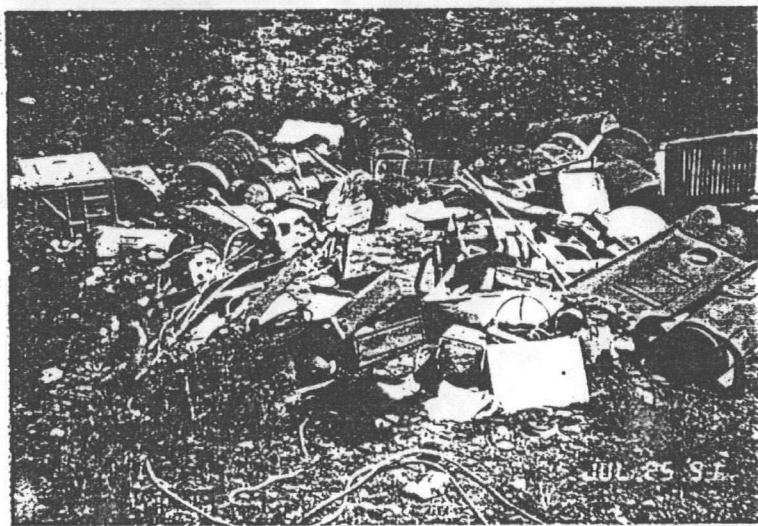
This is the pile of debris
accumulated over time by
the ranchers, miners, and all.
It appears that someone was
using the landfill for a number
of years until the road
leading to the landfill or
was washed out.

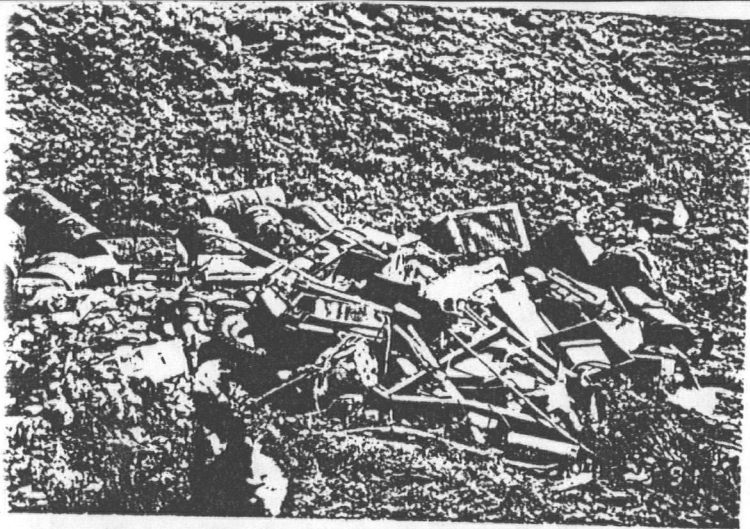
Several small house hold
containers were found to be
lacking their contents onto
the ground. Most of the
larger containers were found
to be empty.

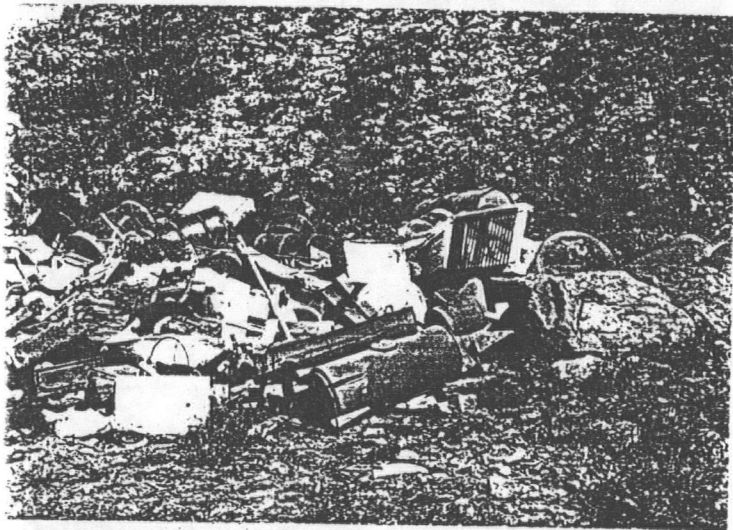
Same trash pile different
view.

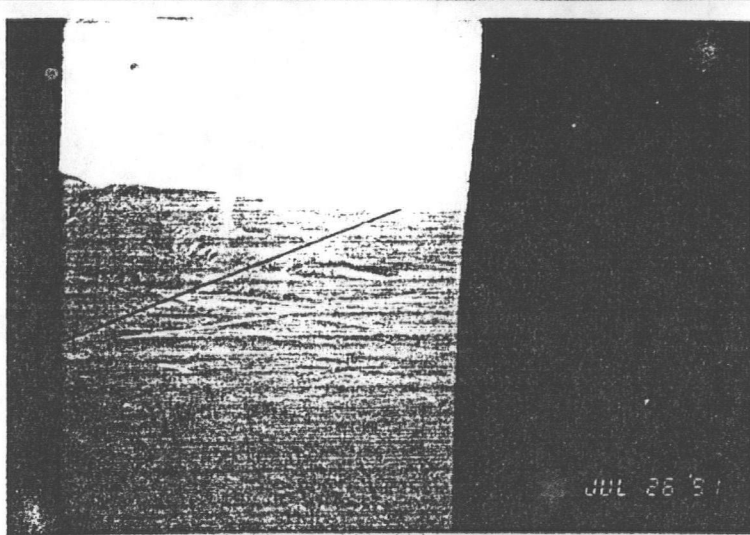
Aerial view of the road leading out to the beachfront. Several small buildings could be seen all along the access road. Outcroppings of these buildings are yet unknown.

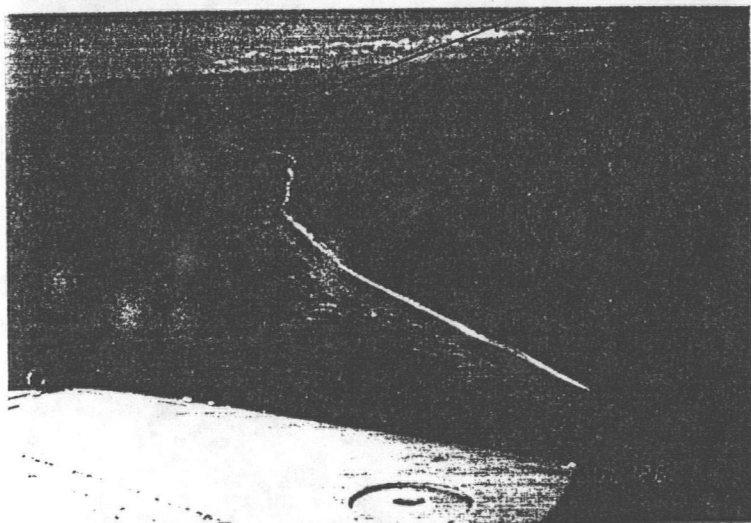
Aerial view of the access road leading to the beachhead. 300,000 gallon tank located there for easy storage! We were unable to inspect this tank due to the access road being washed out.

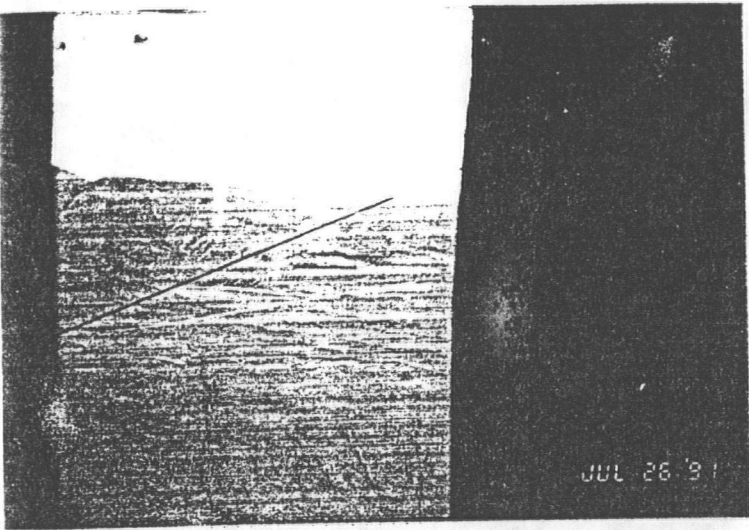
Aerial view of the road leading out to the beachfront. Several small buildings could be seen all along the access road, ownerships of these buildings are yet unknown.
